High performance coatings for the geothermal industry

MATERIALS & TECHNOLOGIES FOR
PERFORMANCE IMPROVEMENT OF
COOLING SYSTEMS IN POWER
PLANTS

The H2020 MATChING project

The geothermal site of Balmatt (Be)

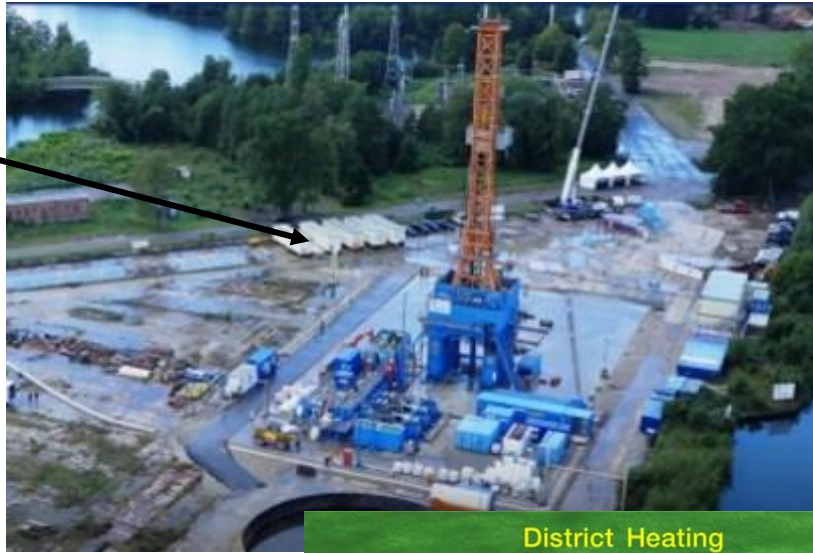
Balmatt Brines*

Production T **125-128 C**

P: **40 bars**

Brine type **Na-(Ca)-Cl**

Salinity: **165 g/l**

Gas brine volume ratio is 2.5

CO₂: 75 vol.%, other CH₄

pH unseparated fluid (with the CO₂) is **5.4**

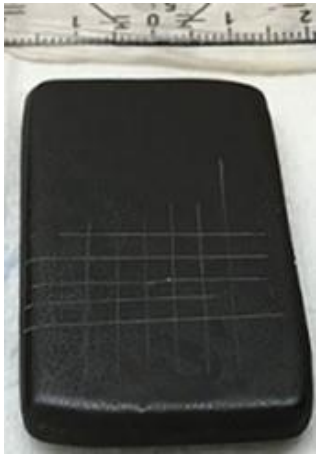
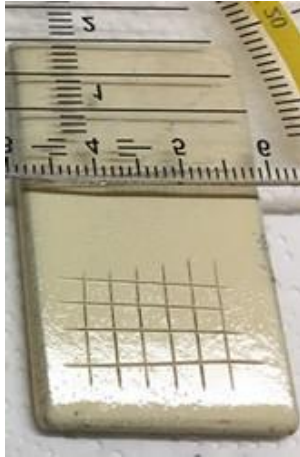
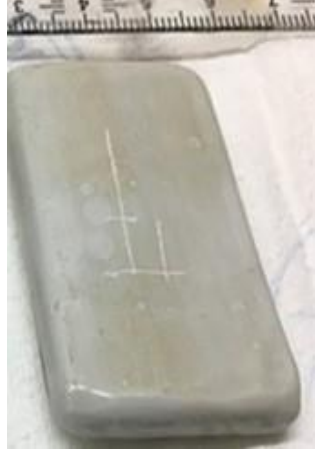
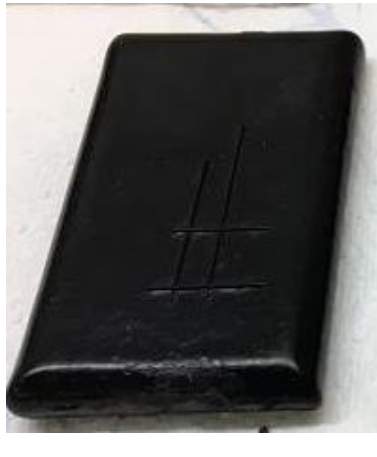
After LOTU test					
Coating A	Coating B	Coating C	Coating D

Coating	Adhesion rating	S.E mN/m	Blistering rating	Rusting rating	Comments
A	0	44	None	Ri 0	No visual signs of degradation
B	0	25	None	Ri 0	No visual signs of degradation.
C	0	44	None	Ri 0	No visual signs of degradation
D	0	<24	None	Ri 0	No visual signs of degradation

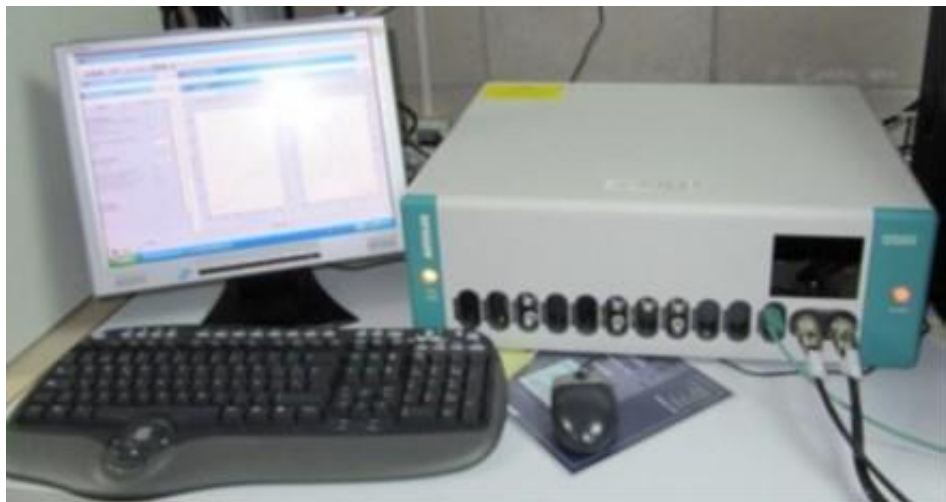
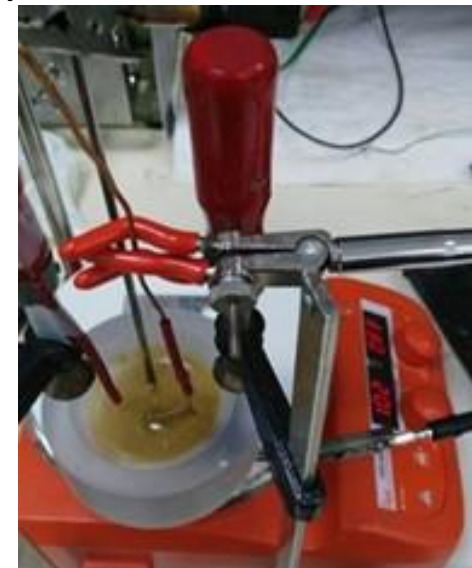
- PGSTAT20 AUTOLAB from Ecochemie®
- Vertical cell arrangement, synthetic brines (50 ml), r.t, open to air and continuous stirring
- Frequency range 100 kHz and 0.1 Hz (5 points per decade), AC potential perturbation of 200 mV (rms)
- Two-electrode configuration placed inside a Faraday cage.

The working electrode was the coated sample, and the exposed surface was 1 cm², a platinum mesh was the auxiliary (counter) electrode and the reference electrode was a platinum wire. The auxiliary electrode and the reference electrode were short-circuited to obtain more accurate measurements.
